west virginia department of environmental remediation
Office of Environmental Remediation

VRP Project #: **15017**
Brownfield Site: Yes ☐ No ☒
Report Date: **3-8-16**
Page **1** of **5**

OFFICE OF ENVIRONMENTAL REMEDIATION
VOLUNTARY REMEDIATION PROJECT
SITE VISIT/INSPECTION REPORT

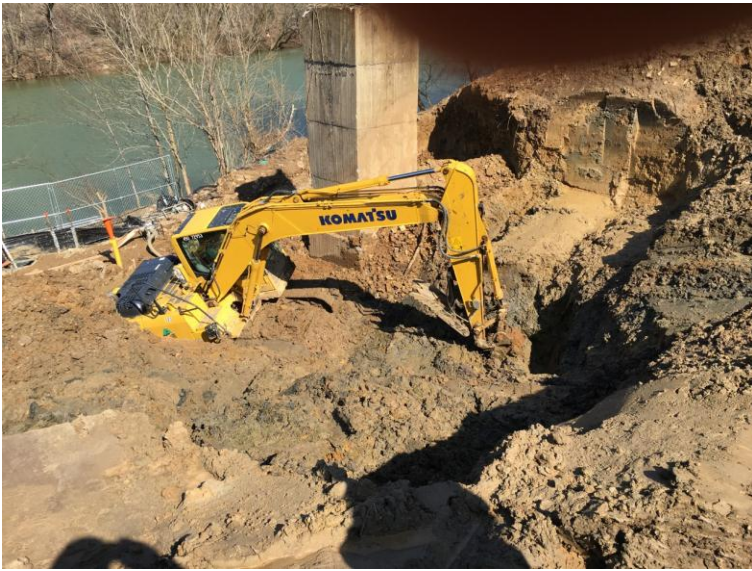
Excavator working at the bottom of the slope trying to prep area for clay cap, however, this area is so wet from natural drainage on the slope that "soil" in this area has consistency of pudding. Excavator has sunk approximately 5 feet into the mud and is currently stuck. Will have to use dozer to pull excavator out of mud. Upper portion of slope is also very unstable and is in danger of sloughing onto excavator and burying it even further. Based on the extremely unstable conditions in this area, rethinking entire slope & capping plan.

1. Excavator stuck in mud at toe of slope.
2. Moving clay capping soil into place to be spread.
3. View of backfilling and capping progress - Area 3.
4. View of Areas 1B & 2 and capping material
5. View of southern side of slope area (Area 4).
6. Sump #8 at base of slope
7. Opened trench north of sump #8 and below former fire suppression system pump.
8. View of excavated area north of former fire suppression system pump (C&D debris excavated)
9. View of slope looking up towards Barlow Drive (to southeast)

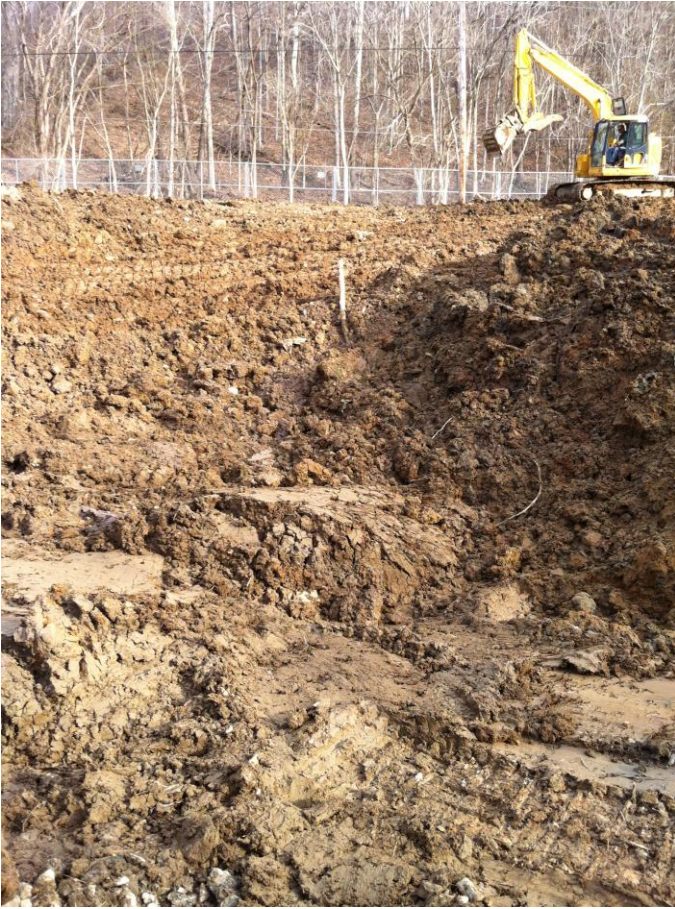
5.

CORE received the geotechnical report today from Terracon from drilling and sampling work completed at the site on February 19, 2016. The report, titled, "Geotechnical Engineering Report - Embankment Fill Stability, Freedom Industry Site, Elk District, West Virginia", basically confirmed the conditions and issues that we were seeing today. The report indicated that based on the native overburden soil in the slope area (medium stiff to very stiff lean clay, very soft to soft silts and very loose to dense poorly graded and well graded sand) coupled with groundwater seepage and runoff during seasonal variations in rainfall, a 3:1 slope results in a global safety factor of only about 1 for the slope, indicating that a 3:1 slope would ultimately fail. The report recommended construction of a drilled pier wall between the toe of the slope and the top of the riverbank, which would retain the Area 4 slope in the event that the riverbank failed. A second option, though not recommended without further study, would be to move the toe of the slope a minimum of ten feet (10') back to the east (towards Barlow Drive), away from the river. With this option, failure of the riverbank slope would not immediately affect the stability of the Area 4 slope and corrective measures would be possible. Since there is no budget for the construction of a pier wall, the immediate solution will be to reduce the Area 4 slope to less than 3:1 and construct a swale in this area

with minimal fill on top to reduce the chance for slippage. The terrace proposed mid-slope will also be eliminated; however these plans will be studied and discussed further in the coming week.
